ENVIRONMENT REHABILITATION ON TROTUŞ RIVER VALLEY, AFTER THE 2004 AND 2005 FLOODS

Ionuţ Popa

Editor-in-Chief TERRA MAGAZIN

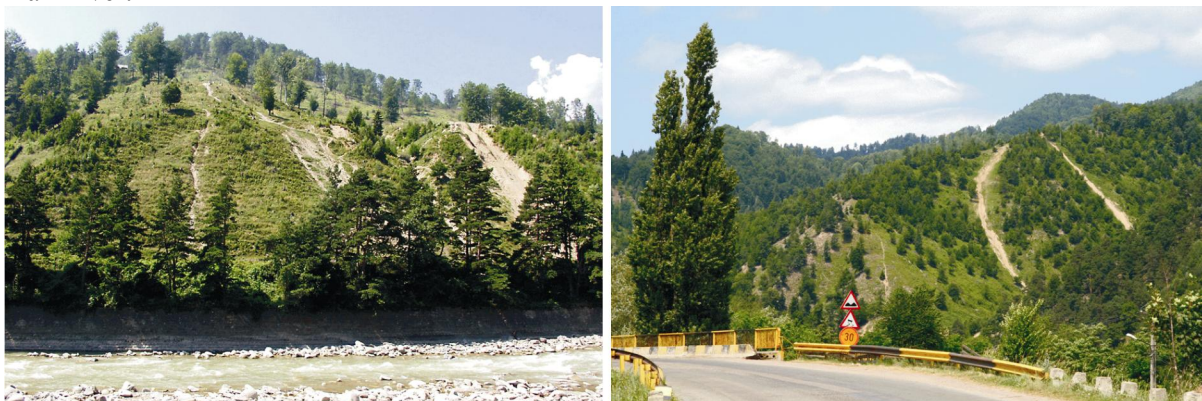
Fig. 1 Deforested slopes in Trotuș river valey (July 2005 and July 2012)

This warning was issued against the background of a long period of atmospheric instability in the mountain area of the Western part of the Bacău County. The high discharges of the Trotuş river and its tributary streams produced floods in the localities Agăş, Asău, Brusturoasa, Comăneşti, Ghimeş, Făget, Palanca, Straja, Tg. Ocna, Viişoara and other 50 localities, due to abundant precipitation (104 l/sqm at the Poiana Uzului weather base, on the 28th of July 2004). Damage was caused to 1,874 houses and house annexes, 216 hectares of cultivated land, 122 kilometers of county roads, 167 bridges and footbridges, 10 mean stress lines, 3 wood working companies in the entire hydrographic basin of the Trotuş river. The flood wave had an impact over the entire area up to the inflow of the Trotuş in the Siret, damaging 21 households with annexes and 8 kilometers of streets in the Adjud locality. The analysis of the data delivered by the Siret Directorate of the Romanian Inland Waters Administration, proved that the precipitation registered on the 28th of July 2004 in the entire Trotuş basin, amounted to considerable quantities. 11 of the 21 hydro-meteorological monitoring stations in the area registered passing showers of torrential rains with large quantities of water in 24 hours. The largest quantity of precipitation registered among the weather bases located in the high Carpathian and Under-Carpathian area of the Trotuş basin was the one registered at the Poiana Uzului weather base, close to the Dărmăneşti locality, on the Uz Valley - 104 l/sqm in 24 hours, while the multi-annual precipitation average registered at this weather base is 622,8 l/sqm, and the maximum quantity registered in the year 1991 was 140 l/sqm. The other hydro-meteorological monitoring stations also registered considerable precipitation (table no. 1). The large quantities of torrential precipitation caused the flood on the 28th of July 2004. Another factor that favored this devastating phenomenon (which, besides the damage also caused the death of three people, two in the Agăş locality, on the Trotuş river, upstream from Comăneşti) is the massive deforestation carried out over the last years, especially after the taking into seisin of the forests according to Law 1/2000. Chaotic wood cutting (some of which even led to the total uncovering of mountainsides over quite wide areas – as seen in Fig. 1), either for wood working companies in the Comăneşti area, or for household use, but especially for smuggling purposes, had as a result the rapid discharge of precipitation water down the mountainsides, the formation of mud streams and floods on the

tributary streams in the mountain area of the Trotuș river, and finally, a strong flood wave in the bed of the main river.

- Chaotic wood cutting, either for wood working companies in the Comănești area, or for household use, but especially for smuggling purposes, with a devastating consequence: rapid discharge of precipitation water down the mountainsides, formation of mud streams and floods on the tributary streams in the mountain area of the Trotuș river, and finally, a strong flood wave in the bed of the main river.

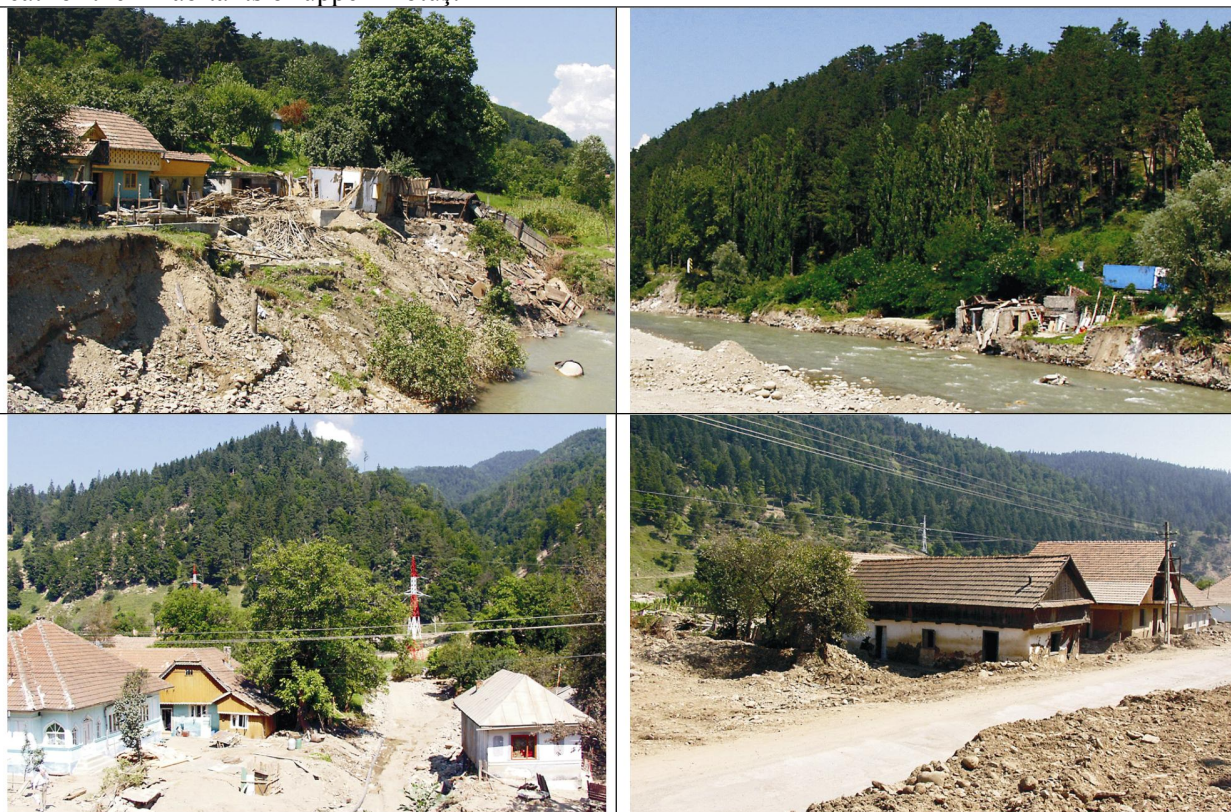
Fig. 4 Destroyed houses in Comănești city, on the Trotuș river banks, and in Ciobănuș village, July 2005

This 11-13 July 2005 flood wave caused the destruction of 305 houses, the flooding of over 5.125 houses and of over 1.750 houses annexes flooded and destroyed (Fig. 4); also, there were some other effects: destruction of 89 bridges and 221 footbridges (these only on the Trotuș), 10 meters of railway, 1 railway bridge, 1 km of national road destroyed (Fig 5) and over 4.000 ha farmland flooded. 1.360 inhabitants were moved in Trotuș river basin.

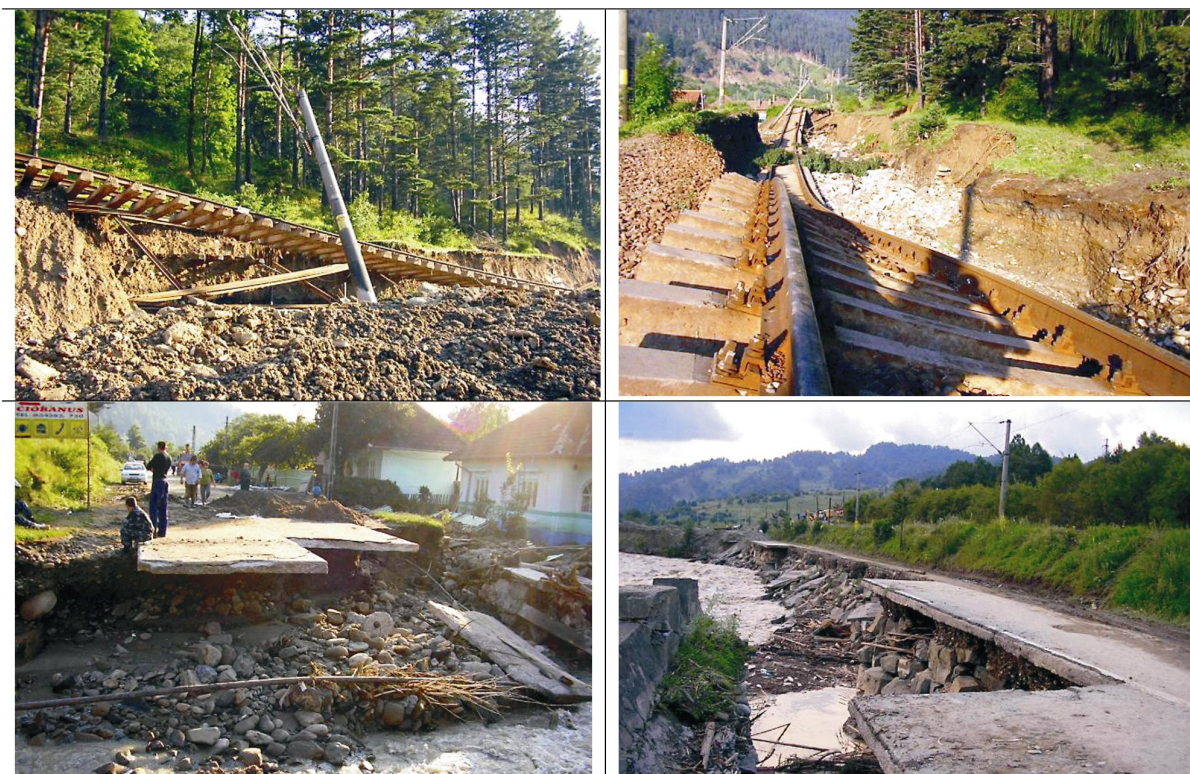
Fig. 5 Adjud – Ciceu railway and Comănești – Ghimeș national road (in the neighborhood of Ciobănuș village), July 2005

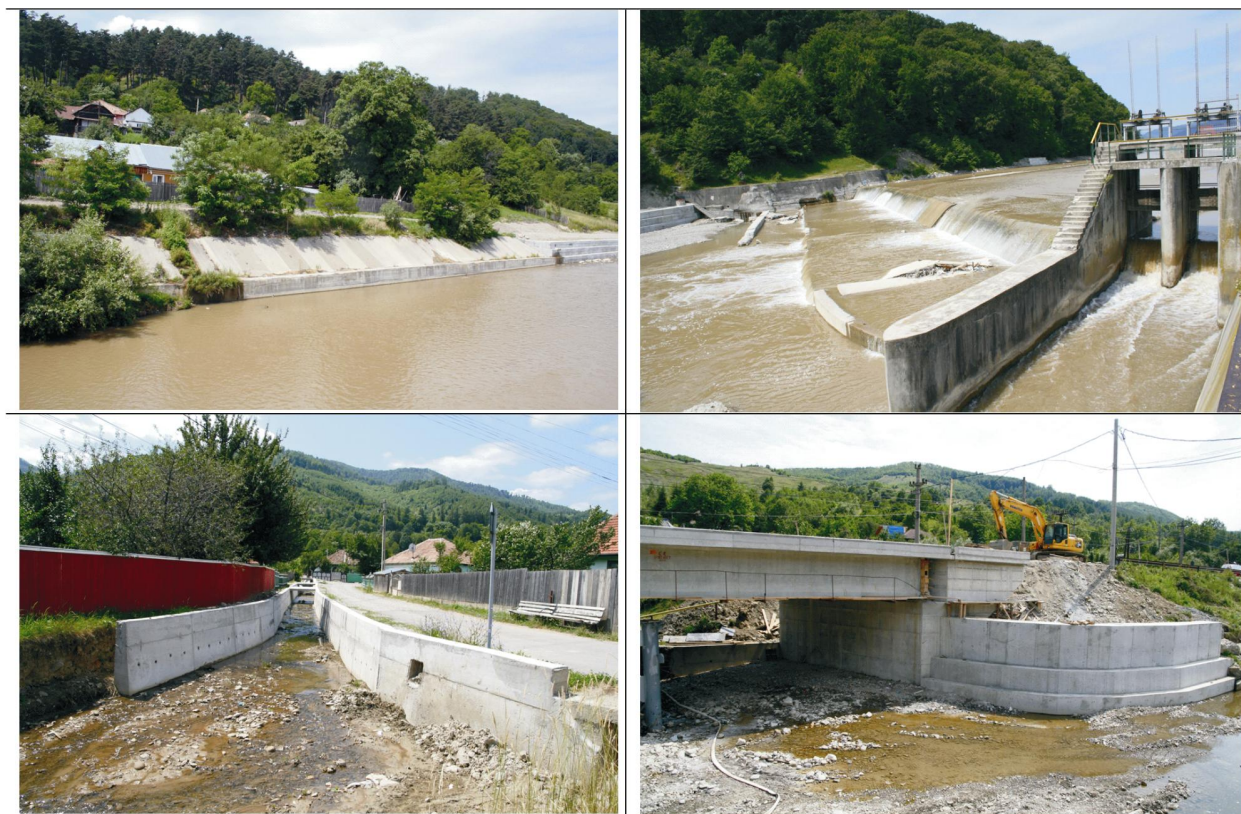
Fig. 6 Rehabilitation of rivers in Trotuș river basin (Trotuș at Comănești, Straja and Slănic tributaries), July 2012

For Trotuș river basin, including small afluent, this action plan includes rehabilitation of riverbeds, raising of dams on the riverbanks and completely damming the sectors with high flooding risk, engineering and hydrotechnic works inside the riverbeds of small tributaries and on the slopes with destructive potential (as seen in Fig. 6)
