Dobranský M., Zeleňáková M. (2023), The process of revitalization of the river branches of the Žitava River near the wetland Žitavský Luh, pp. 230-236. In Gastescu, P., Bretcan, P. (edit., 2023), Water resources and wetlands, 6th International Hybrid Conference Water resources and wetlands, 13-17 September 2023, Tulcea (Romania). pp. 287

6th International Hybrid Conference Water resources and wetlands, 13-17 September 2023, Tulcea (Romania)

THE PROCESS OF REVITALIZATION OF THE RIVER BRANCHES OF THE ŽITAVA RIVER NEAR THE WETLAND ŽITAVSKÝ LUH

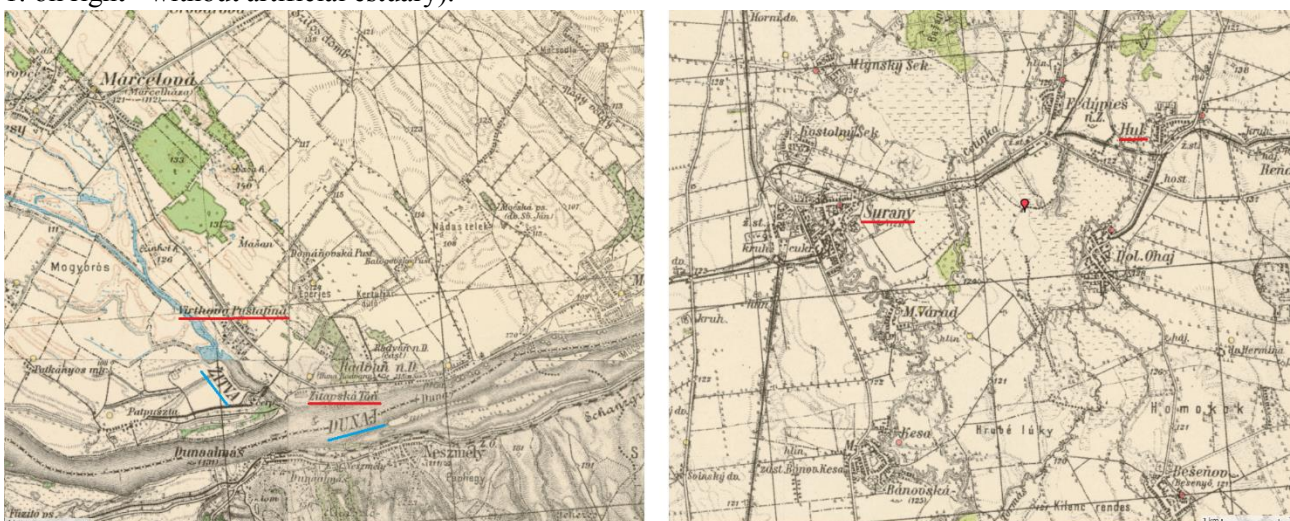
Figure 1. Historical map of the Žitava River (1938).

Back in 1606, when the Treaty of Žitava was signed, the "Old" Žitava, specifically one of its main branches at the time, entered the Danube river near the settlement of Žitavská Tôň (Figure 1. on left). The remnant of the river from those times is currently Lake Virt. Of course, today's mouth of "Old" Žitava to Nitra river near Martovce city is well known. The peak of man's expansion into the river flow is the drastic interventions in the 20th century, especially during the totalitarian regime. In addition to straightening the channel, the so-called the "New" Žitava branch starting south of Hul city, the channel that diverts part of the Žitava water through the new, artificial estuary to the Nitra river, located already east of Šurany City (Figure 1. on right - without artificial estuary).

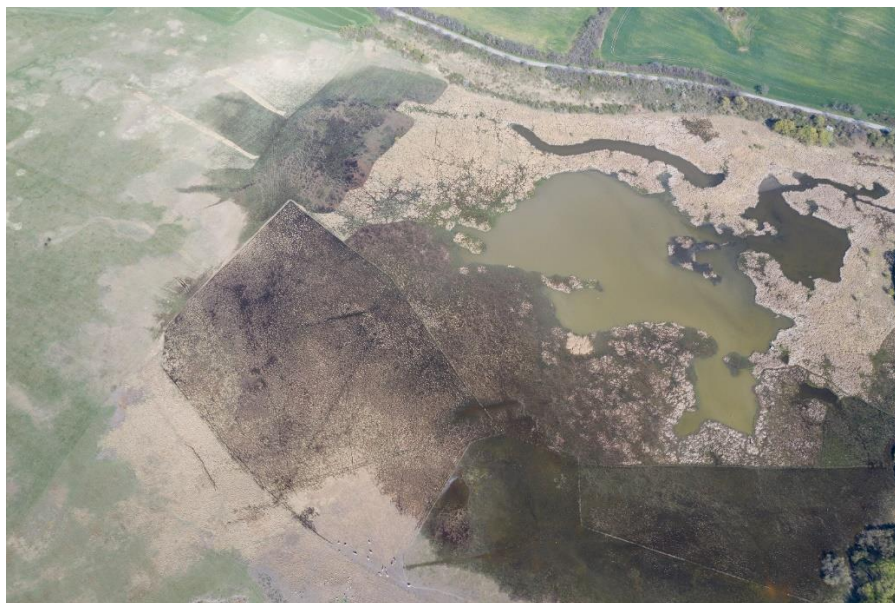
Figure 4. Aerial photo of partially visible existing branches of “Old” Žitava in wetland area.

The subject of landscaping in the *Žitavský Luh* will be the restoration of the original ones (A) and addition of new branches (Figure 4). The proposed modifications will ensure revitalization of the main branch between the new intake structure, where it will be subsidized with water directly from “New” Žitava, and the outlet structure in lateral levee. The nature of the revitalization consists in the restoration of two visible terrain depressions (remains of old branches) and the connection of these branches with the main one. The given main branch will have width at the bottom 3 m, slopes of the bank 1:2 at a depth of 0.4 to 1 m. The total length of the revitalization of the branches is 2.105 km. As a result of landscaping, there will be no violation of the land cover and thereby influencing the groundwater levels in the vicinity.

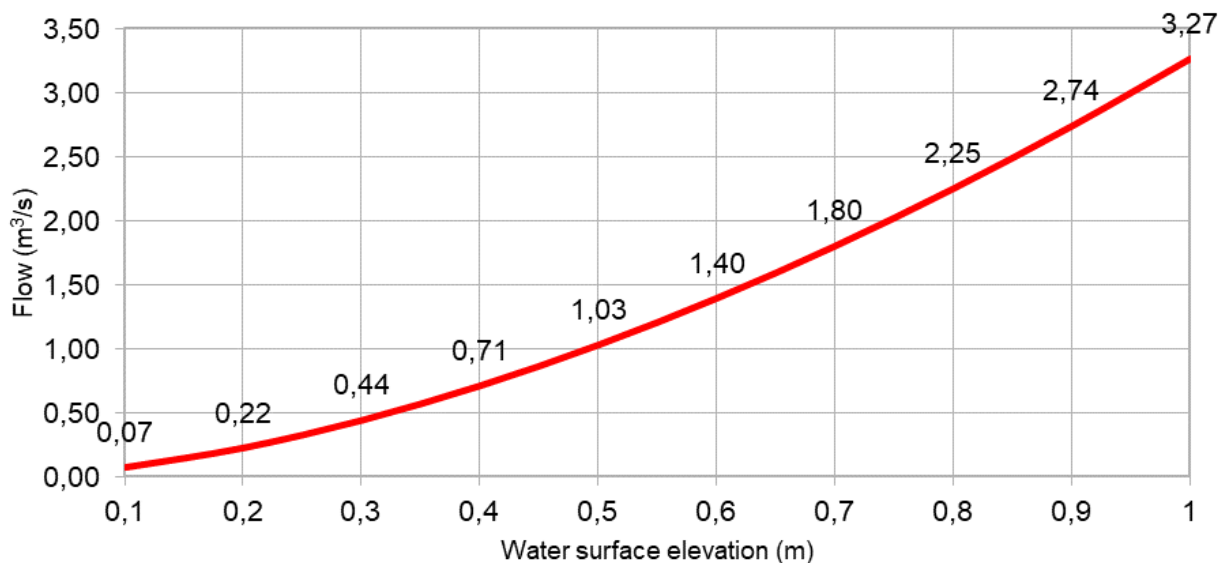
Rating curve for inlet (1x1 m)

Graph 1. Rating curve for the inlet

The intake structure (C) is designed as a reinforced concrete one, which consists of an inlet and a culvert, and an outlet cover shaft. Inlet with overflow edge at elevation 132.25 m.a.s.l., allows flowing only when ensuring the required biological flow necessary for fishway (shown in Graph 1).
