## FISH MIGRATION SYSTEM OVER A WOODEN DISCHARGE SILL LOCATED ON THE BISTRA MĂRULUI RIVER

**Keywords:** fish migration, lotic ecosystem, Bistra Mărului River, fish passage, discharge sill.

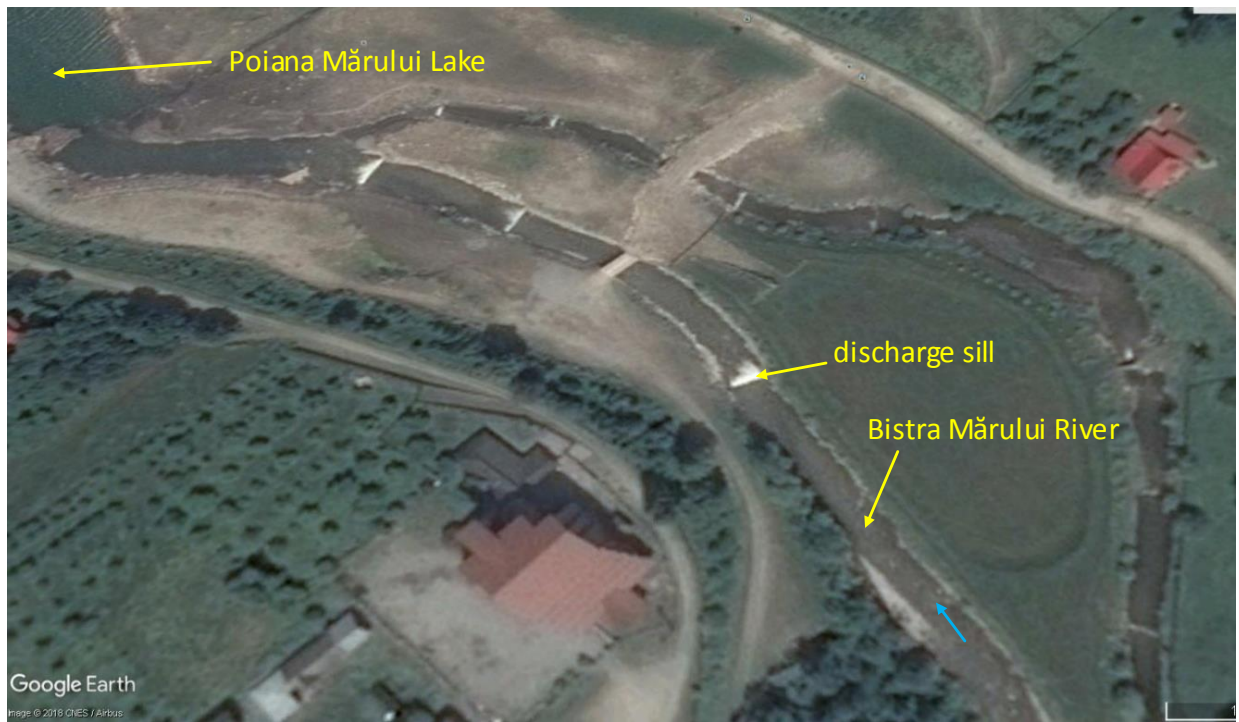
**Figure 1a.** Discharge sill located on the Bistra Mărului River (google earth.com)

The over 12 discharge sills on the Bistra Mărului River and its tributaries block both migratory and non-migratory species. On the Bistra Mărului River there are several discharge sills made of wood materials (figure. 1a). One of them is made of a tree with a diameter of 1,2m fixed in the banks of the river (figure 1b). The fall of water is slightly more than 1 m, which completely blocks any migratory species of fish on the Bistra Mărului river. The length of the spill threshold is 8 meters. The Bistra Mărului River is located in the Timiș river basin. The length of the Bistra Mărului River is about 34 km, the surface of the river basin is about 291 km<sup>2</sup> and the multiannual average flow is about 2 m<sup>3</sup>/s.

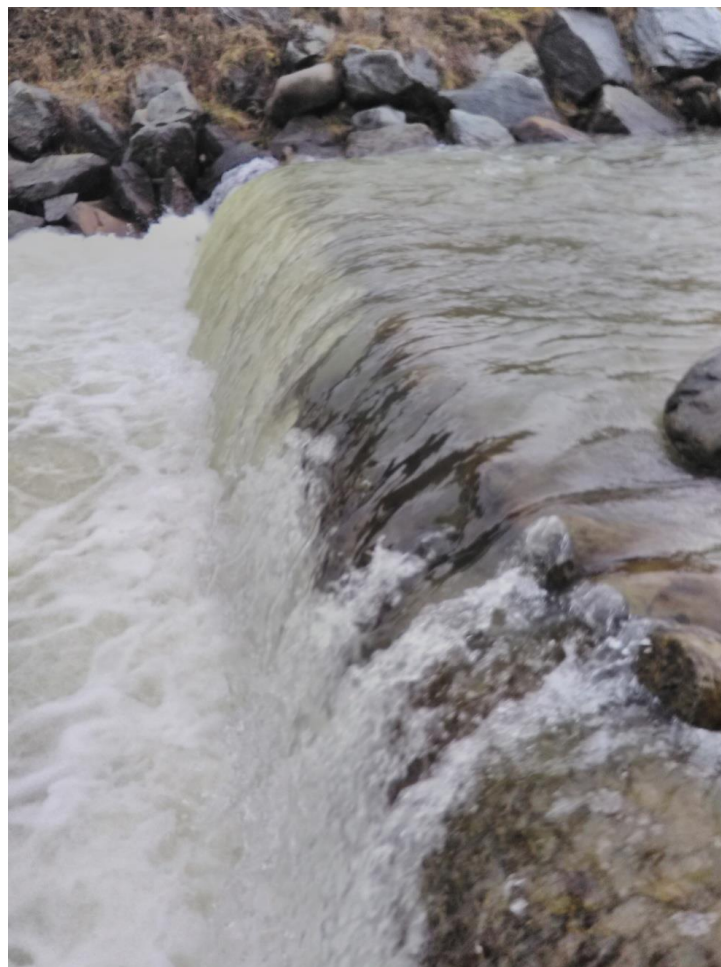
**Figure 1b** The discharge sill made from a tree

Fixed on the discharge sill are wooden bars that have the role of dissipaters (figure 1b). On the discharge sill (shaft), a crenel of 40cm wide and 60cm length will be made. The upper edges of the crenellate remain semi-circular (figure 2).
